COUNTIES (MD/PA) WASHINGTON/FRANKLIN
M&D milestone no. 96 (99)
MHT-HSI no. WA-I-483

FIELD SHEET: MASON & DIXON LINE, MARYLAND-PENNSYLVANIA BOUNDARY MARKER SURVEY

DESCRIPTION/MEASUREMENTS: original/replica/repayment/date 1767; squared oolitic
limestone post, standing only about 6" above top of mound; P on N/S, M on S/S

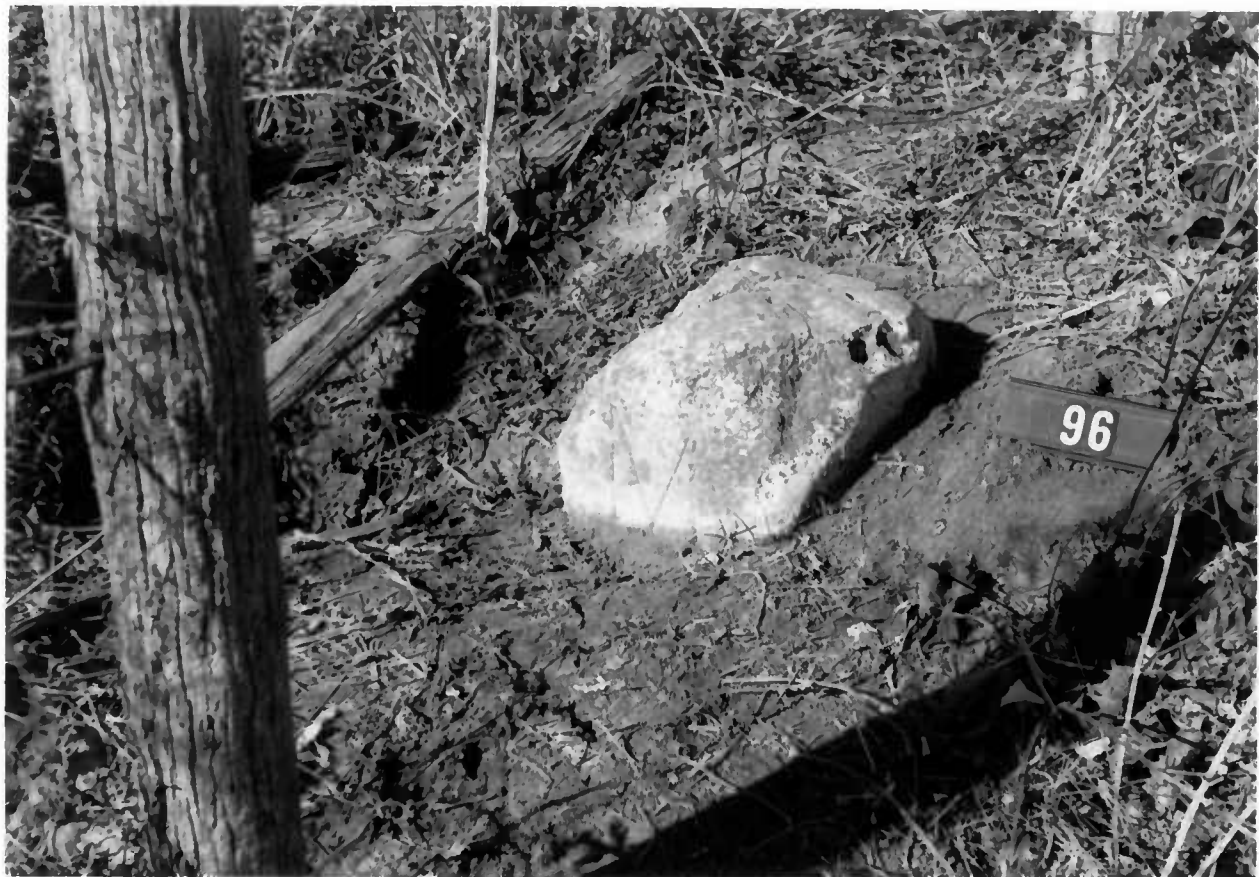
MASON EDIXON WEST LINE: MILESTONE 40 (44)
SE CORNER (M)-

S face (MD): $12\frac{3}{4}$ " wide x 9" high; M fairly intact & clear; large chunks out of top
corners; very weathered

top: no planes remain; very disfigured & weatherworn; large chips all
top corners & edges, especially SE & SW; linear cuts & 2 holes

MGS will want to contact the Fosters about the condition of the site: earth mound should be dug away about 1' to better expose stone (and allow inspection of stone condition); mound and posts could be tidied up.

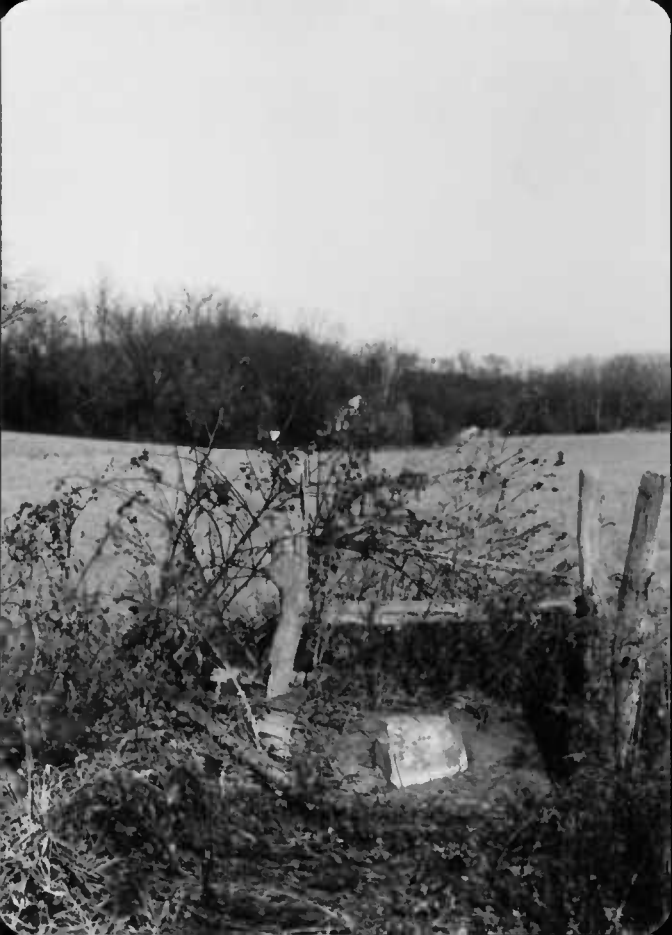
STONE 96 (99)

SW CORNER (-1M)

LOOKING NNE TOWARD FOSTER
HOUSE & BARN

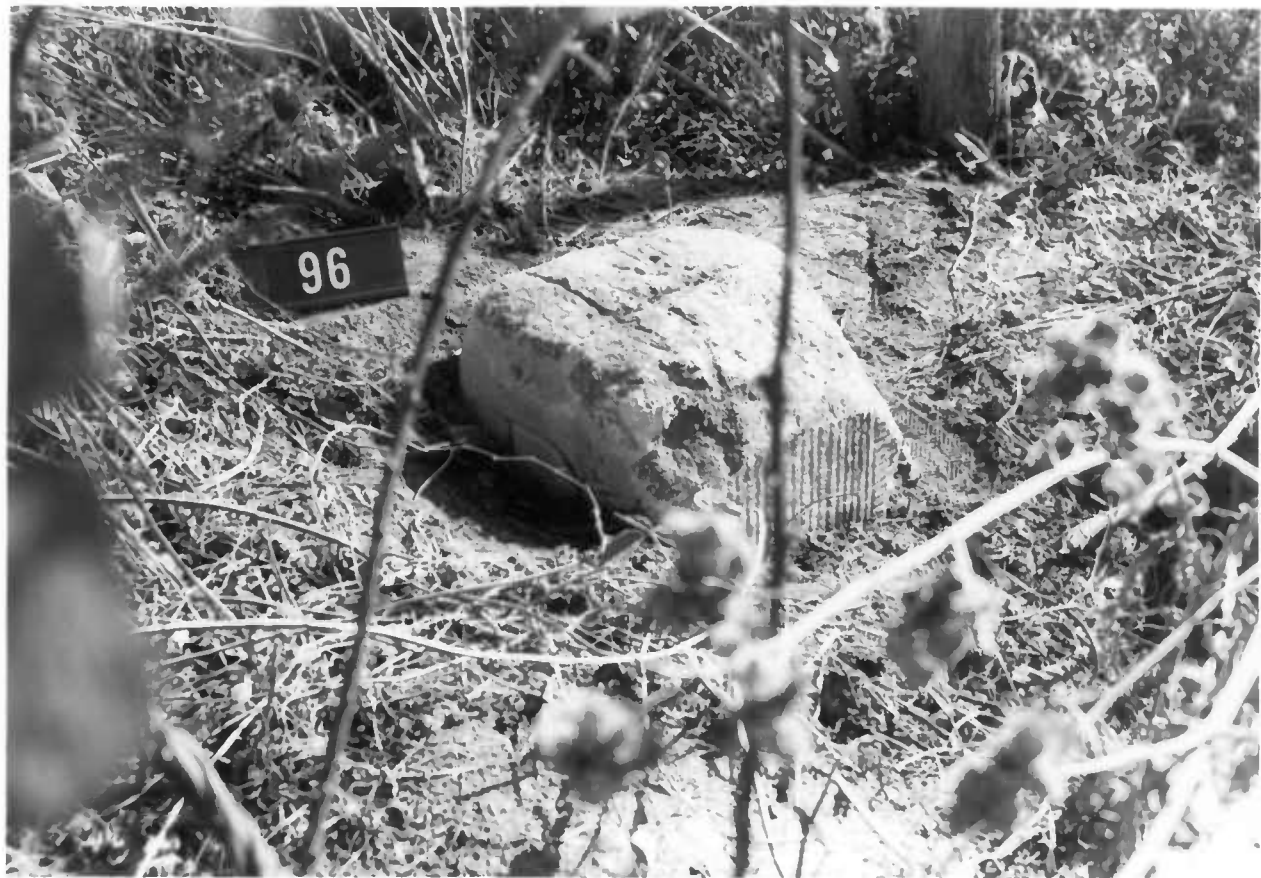
MASON: DIXON WEST LINE: MILESTONE 96 (34)
NW CORNER (P/-)

N face (PA): $12\frac{3}{4}$ " wide x 7" high; P clear but only partially exposed; large chunk
out of top NW corner; chips along top edge

W face: $12\frac{1}{2}$ " wide x 8" high; fluting distinct & some margins; top corners &
edge broken off

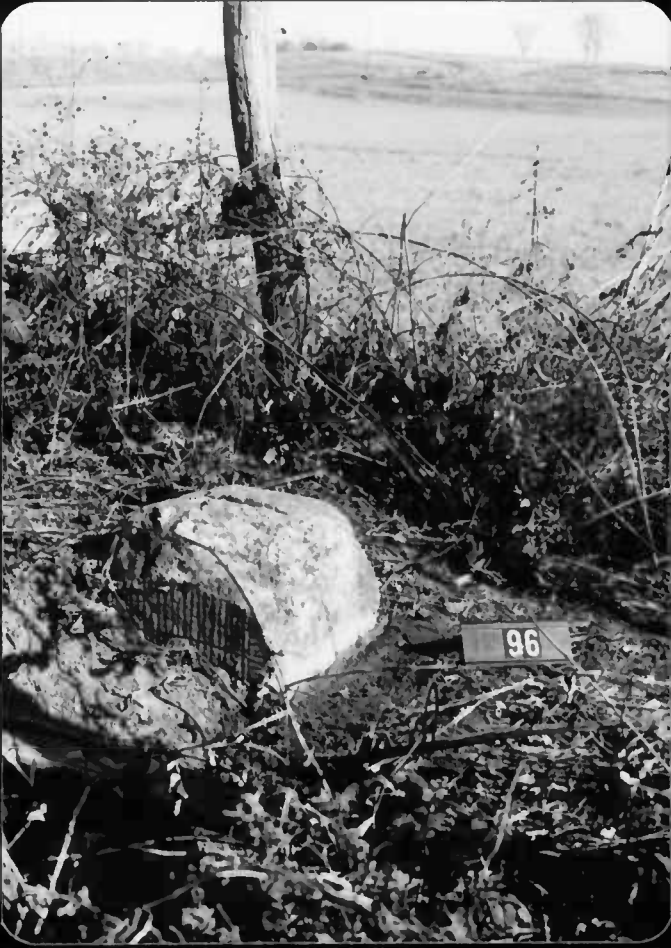
MILESTONE 96 (99)

SW CORNER (-/M) LOOKING
E TOWARD HOUSE & BARN
(FOSTER TENANT HOUSE?)
